PHASE I GEOLOGIC FAULT DESKTOP REVIEW

MEMORIAL DRIVE RECONSTRUCTION AND ACCESS MANAGEMENT

HOUSTON, TEXAS

**Phase I Geologic Fault Desktop Review
Memorial Drive Reconstruction and Access Management
From East of Beltway 8 to East of Tallowood Road
Harris County, Texas**

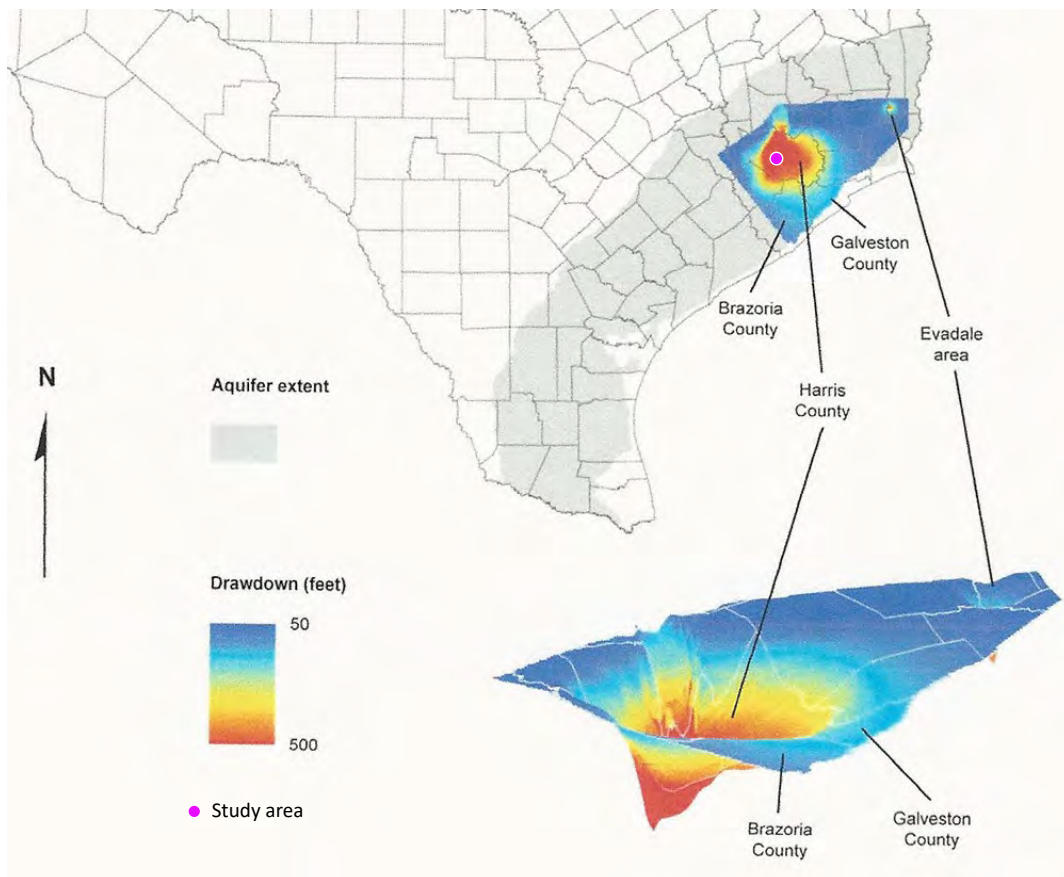
MAP DISPLAYING AQUIFER DRAWDOWN OF HOUSTON AREA

Note:
The study area is located within an area of heavy drawdown influence

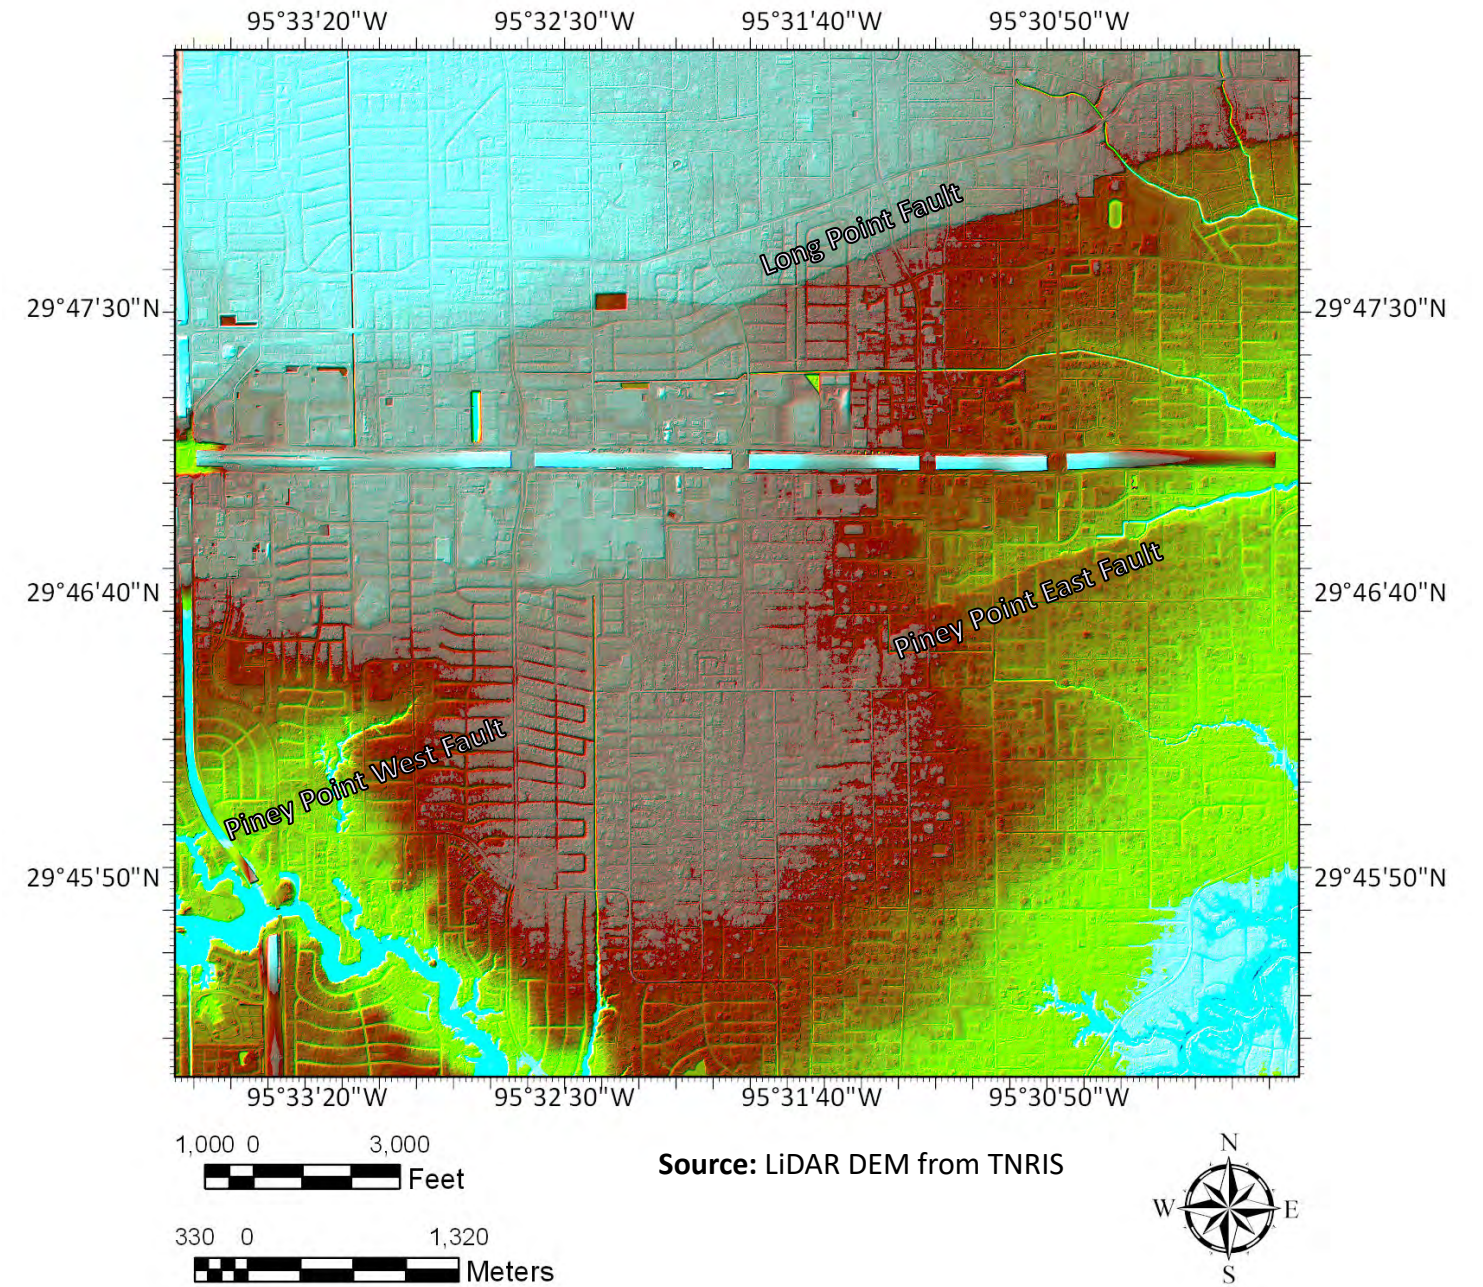
LONG POINT - PINEY POINT FAULT SYSTEM

One principal fault, PPWF, has been previously mapped to intersect the study site (See Plate 4).

The Piney Point Fault System displays alignment with two northeast-southwest trending tributaries of Buffalo Bayou. The congruence in the orientation of both the faults and the tributaries can be seen when comparing the previously mapped position of the fault system and the 1-foot contour interval topographic maps (see Plates 4, 5, & 6). Furthermore, the

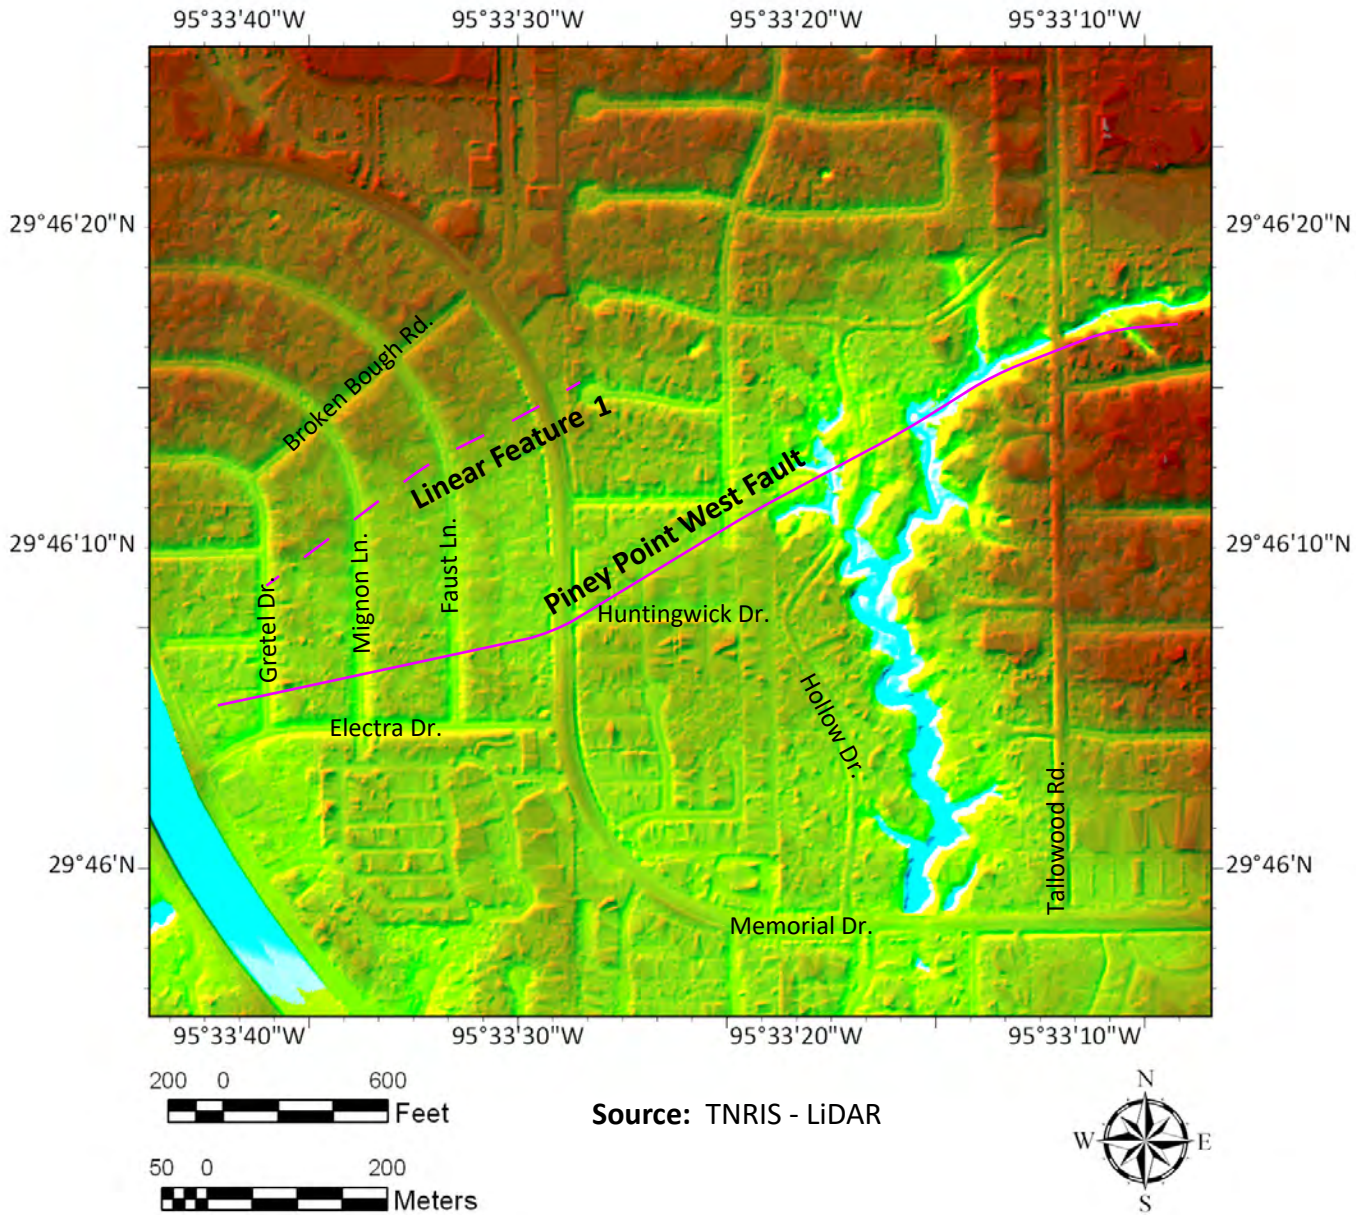
LIDAR-DERIVED SHADED RELIEF MAP

The alignment of the PPWF was supported by producing shaded relief maps of the study area. The shaded relief maps displayed a linear feature, the PPWF, with higher elevation in the southeast and a lower elevation in the northwest. A separate linear feature was present parallel to the PPWF approximately 500 feet to the north (see Plate 5). This second linear feature displayed a lower elevation to the southeast and a higher elevation to the northwest – antithetic to the PPWF. The separate linear feature will be referred to as Linear Feature 1 in the remainder of this report.

The study described above has shown that one previously mapped principal fault intersects the study area along Memorial Drive approximately between Station 26+00 and Station 27+00 from LAN's plan set. This fault, the PPWF, is expressed in both the LiDAR Shaded Relief Maps and the Topographic Maps of the study area. Minor structural damage has also been documented by previous studies of the area, but observations made during our field reconnaissance found that the surface expression of the fault is subtle within the study area suggesting minor to negligible amounts of recent movement along the fault.

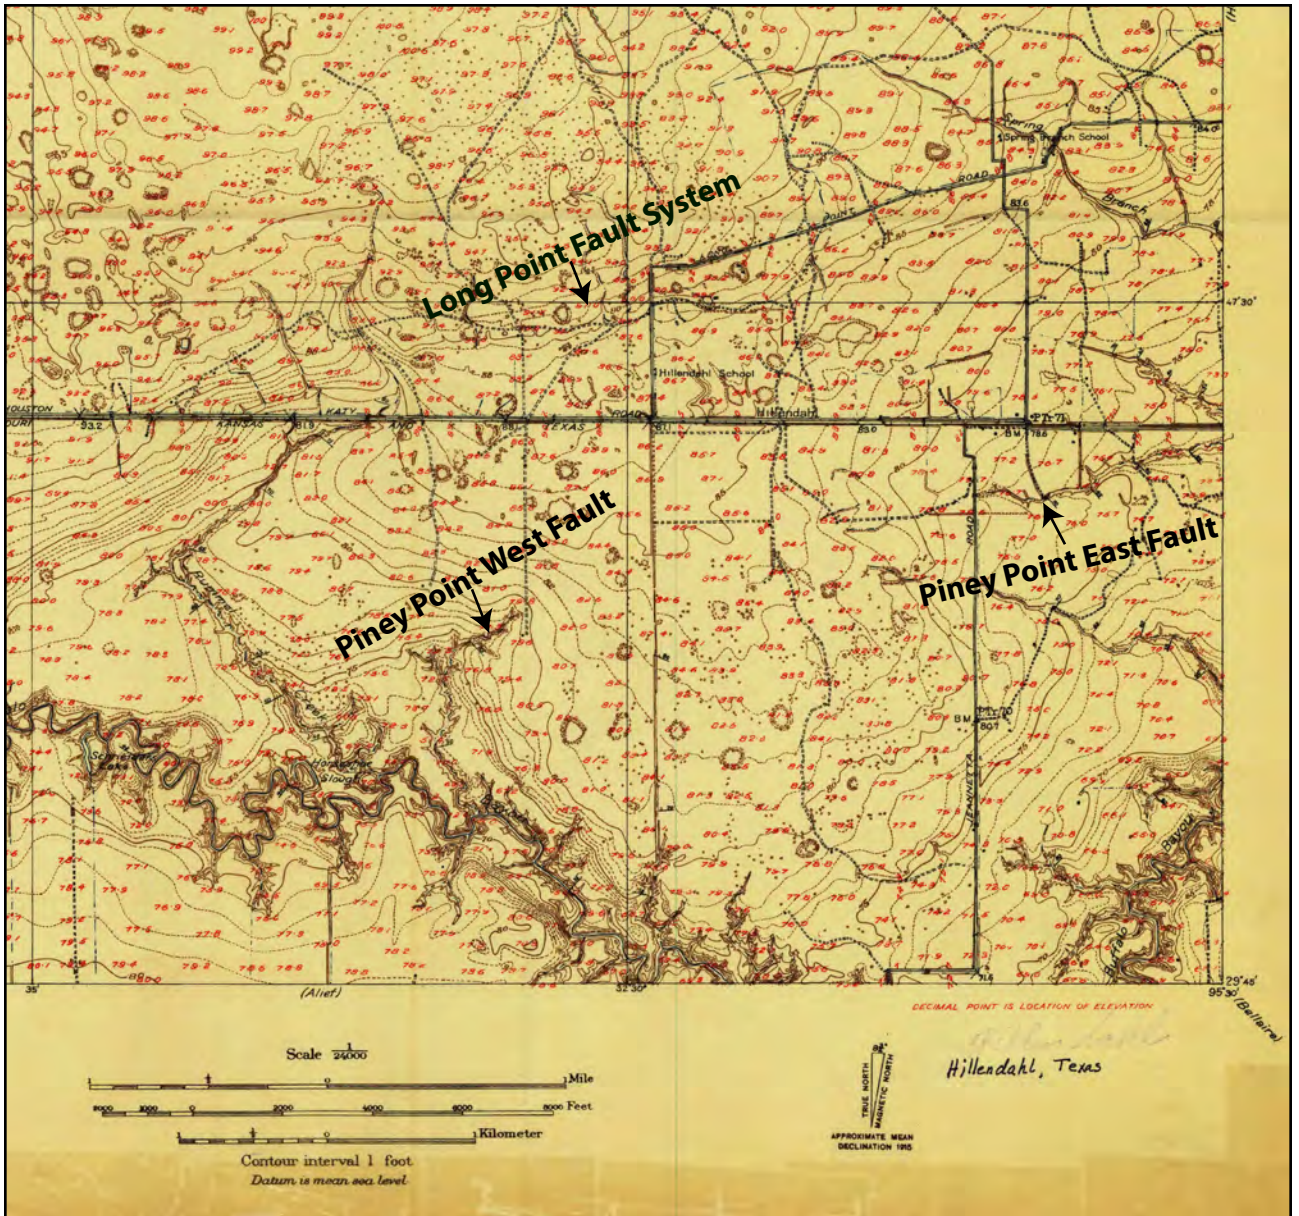
TOPOGRAPHIC MAP

presence of the tributaries along the down-thrown block (northwest) of the fault system further supports a relationship between geomorphology and faulting in the area; the correlation suggests that the topographic depression produced by movement of the down-thrown block could have provided a preferred drainage pathway along the trace of the fault.
