TIRZ 17 BOARD MEETING

May 9th Event Summary

May 28, 2019

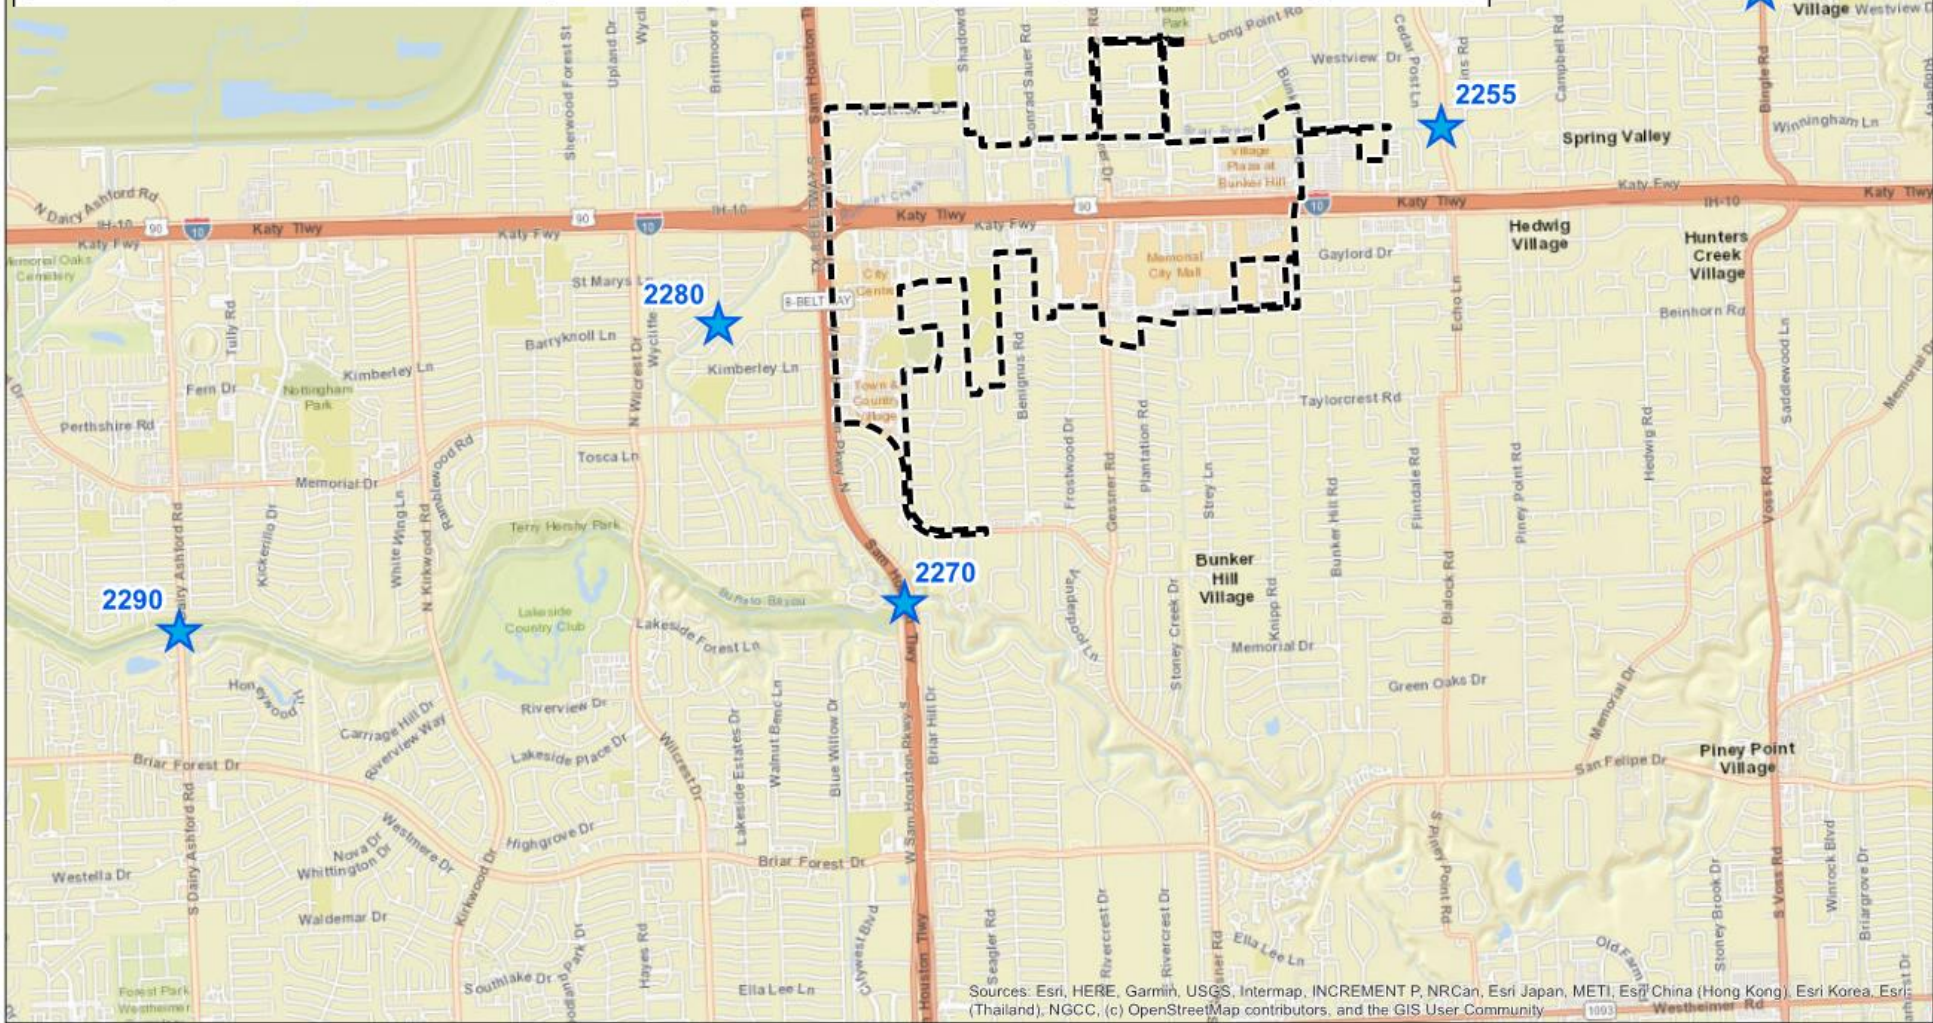
MAY 9, 2019 RAINFALL EVENT ANALYSIS

May 9, 2019 Rainfall Return Period vs Effective Frequency Rainfall Data

Gauge #	Duration (hr)								
	5-min	15-min	30-min	1-hour	2-hour	3-hour	6-hour	12-hour	1-day
2250	0.4	1.0	1.8	2.1	3.4	4.3	5.2	5.8	5.9
2255	0.36	1.0	1.8	2.0	3.4	3.9	4.6	5.2	5.2
2270	0.32	0.6	0.9	1.3	2.1	2.8	3.5	4.1	4.1
2280	0.36	0.9	1.7	2.1	3.0	4.0	4.4	4.9	5.0
2290	0.44	1.1	1.9	2.8	4.4	5.0	5.7	6.2	6.2

ESTIMATED RETURN PERIOD BASED ON EFFECTIVE RAINFALL

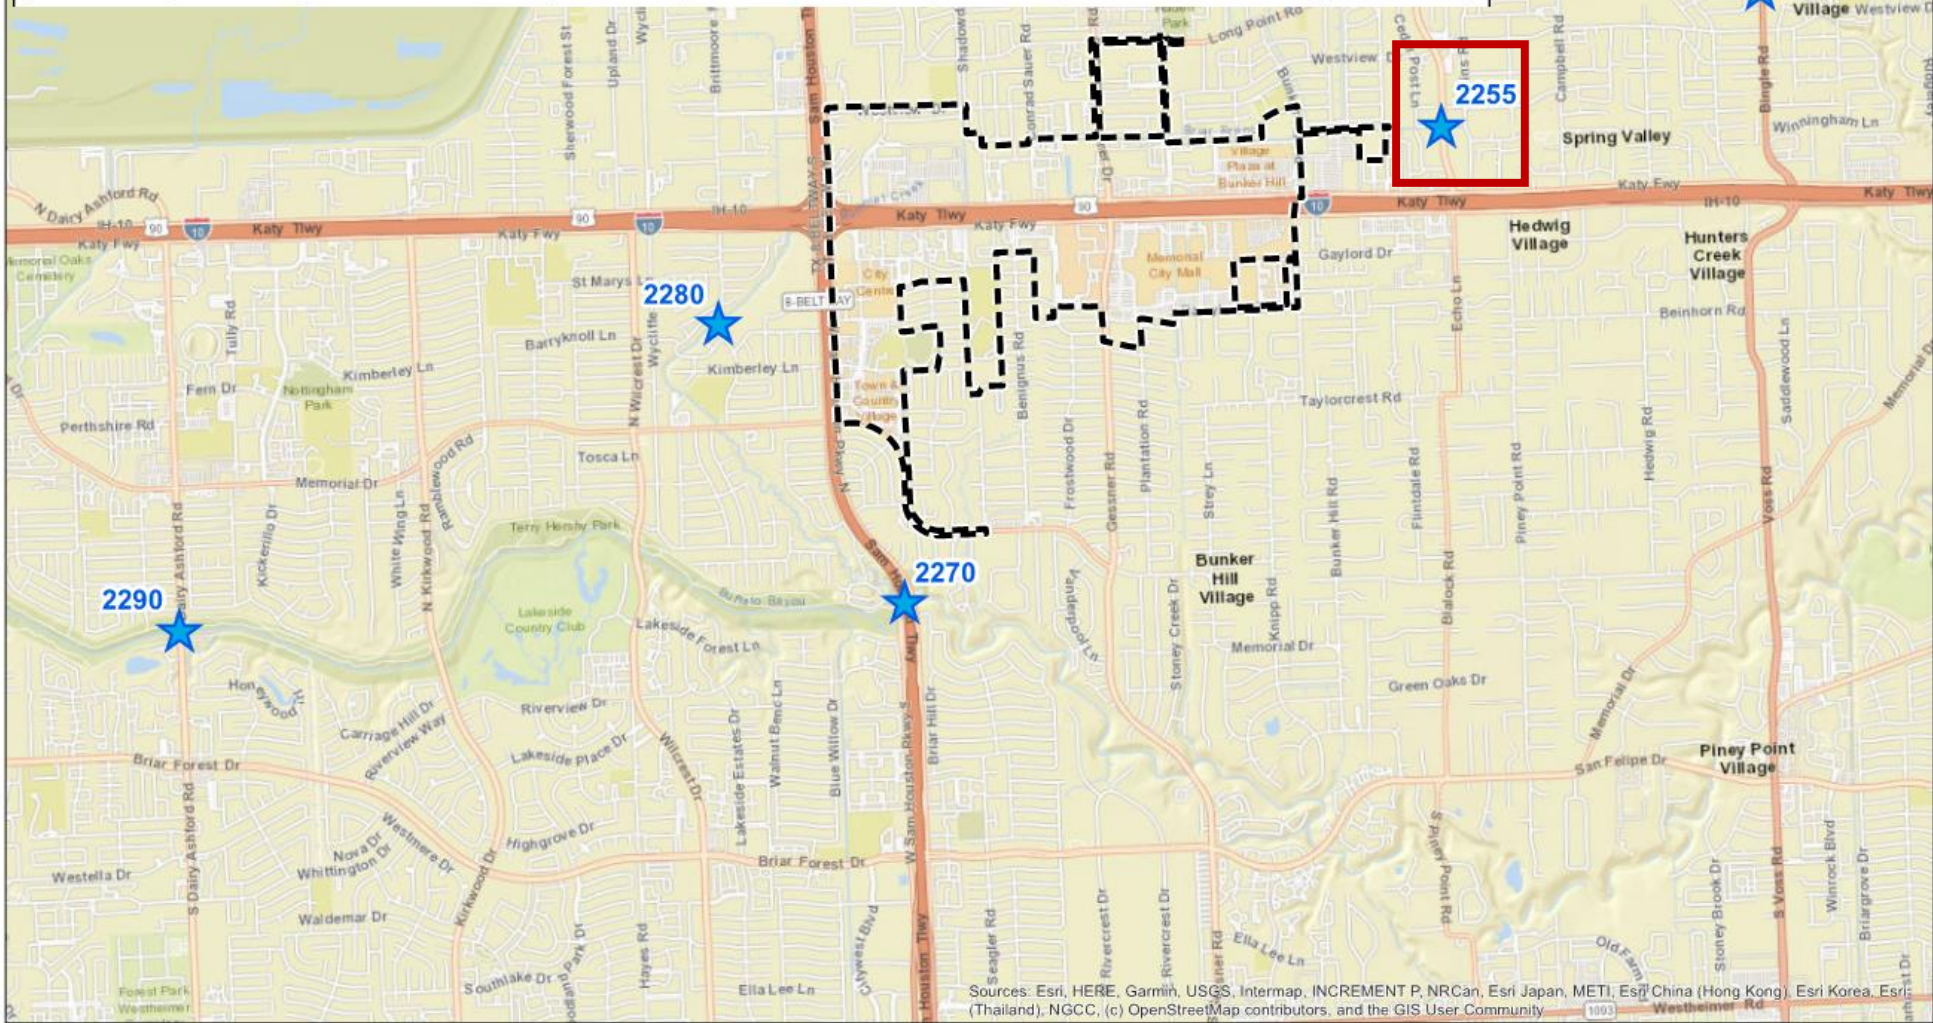
MAY 9, 2019 RAINFALL EVENT ANALYSIS

May 9, 2019 Rainfall Return Period vs Effective Frequency Rainfall Data

Gauge #	Duration (hr)									Return Period
	5-min	15-min	30-min	1-hour	2-hour	3-hour	6-hour	12-hour	1-day	
2250	0.4	1.0	1.8	2.1	3.4	4.3	5.2	5.8	5.9	10-year
2255	0.36	1.0	1.8	2.0	3.4	3.9	4.6	5.2	5.2	25-year
2270	0.32	0.6	0.9	1.3	2.1	2.8	3.5	4.1	4.1	50-year
2280	0.36	0.9	1.7	2.1	3.0	4.0	4.4	4.9	5.0	100-year
2290	0.44	1.1	1.9	2.8	4.4	5.0	5.7	6.2	6.2	500-year

ESTIMATED RETURN PERIOD BASED ON EFFECTIVE RAINFALL

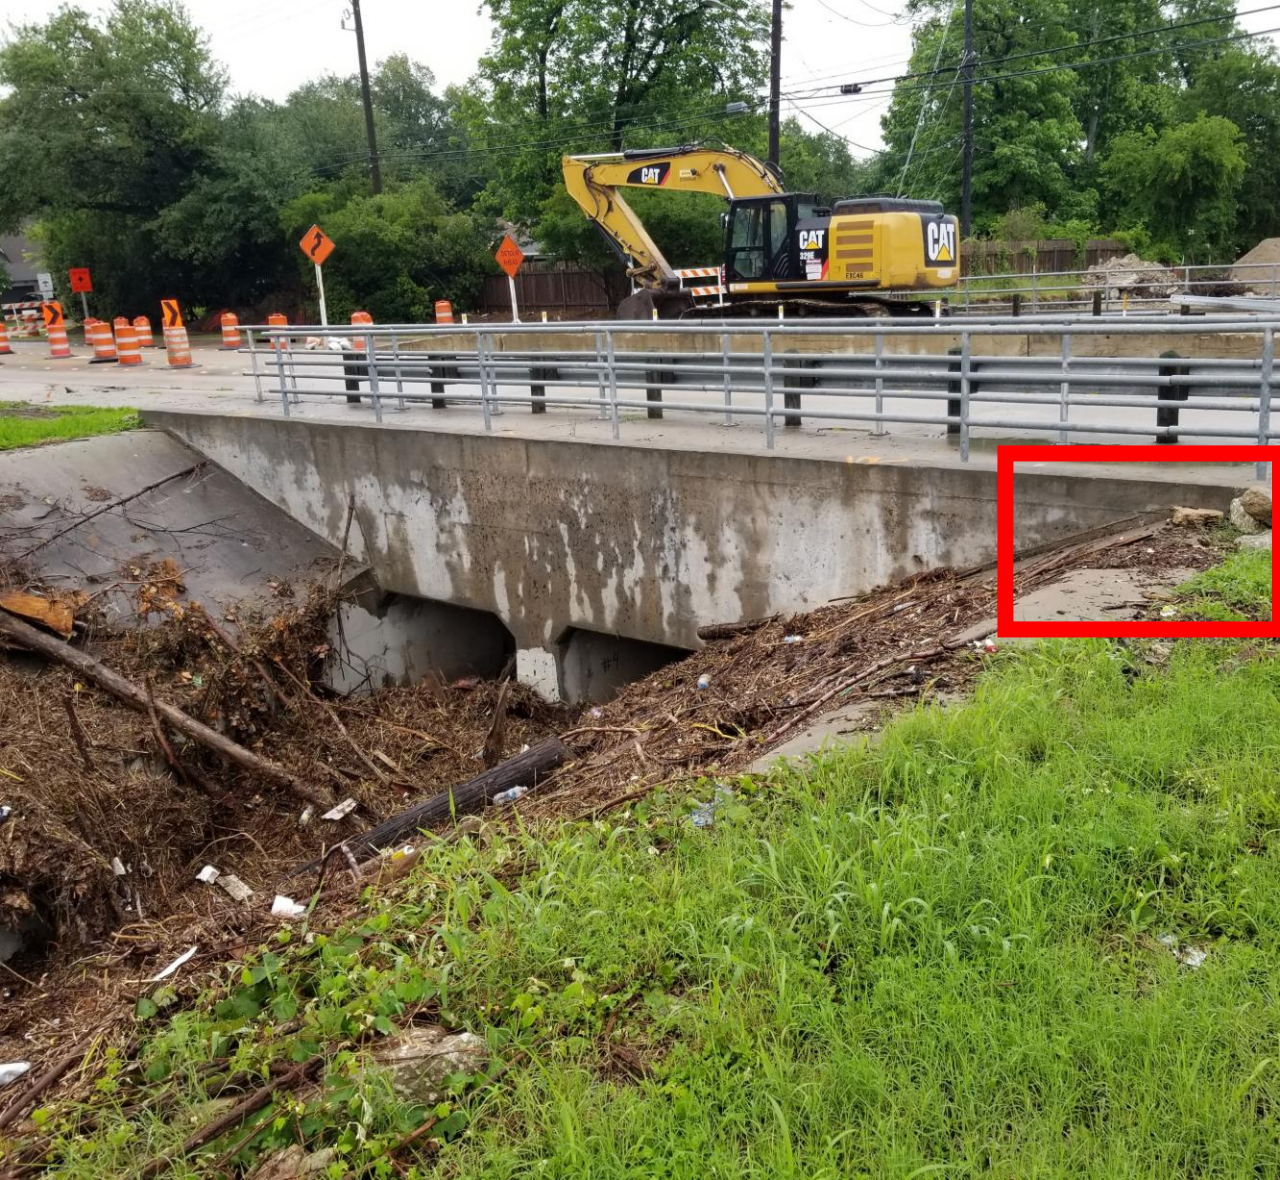
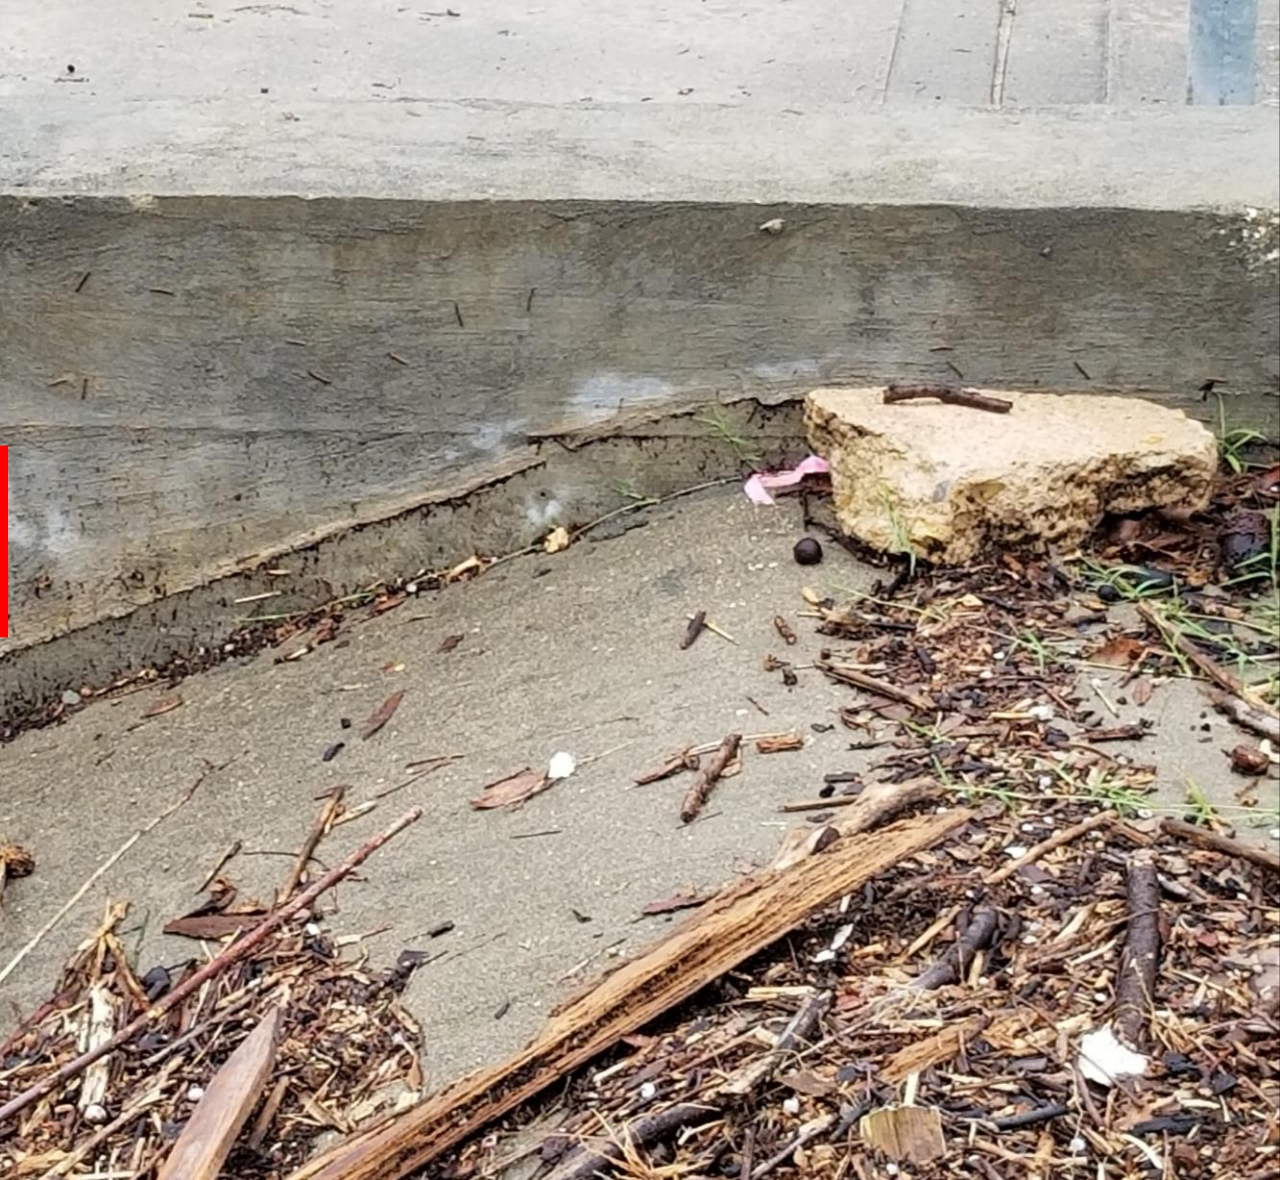
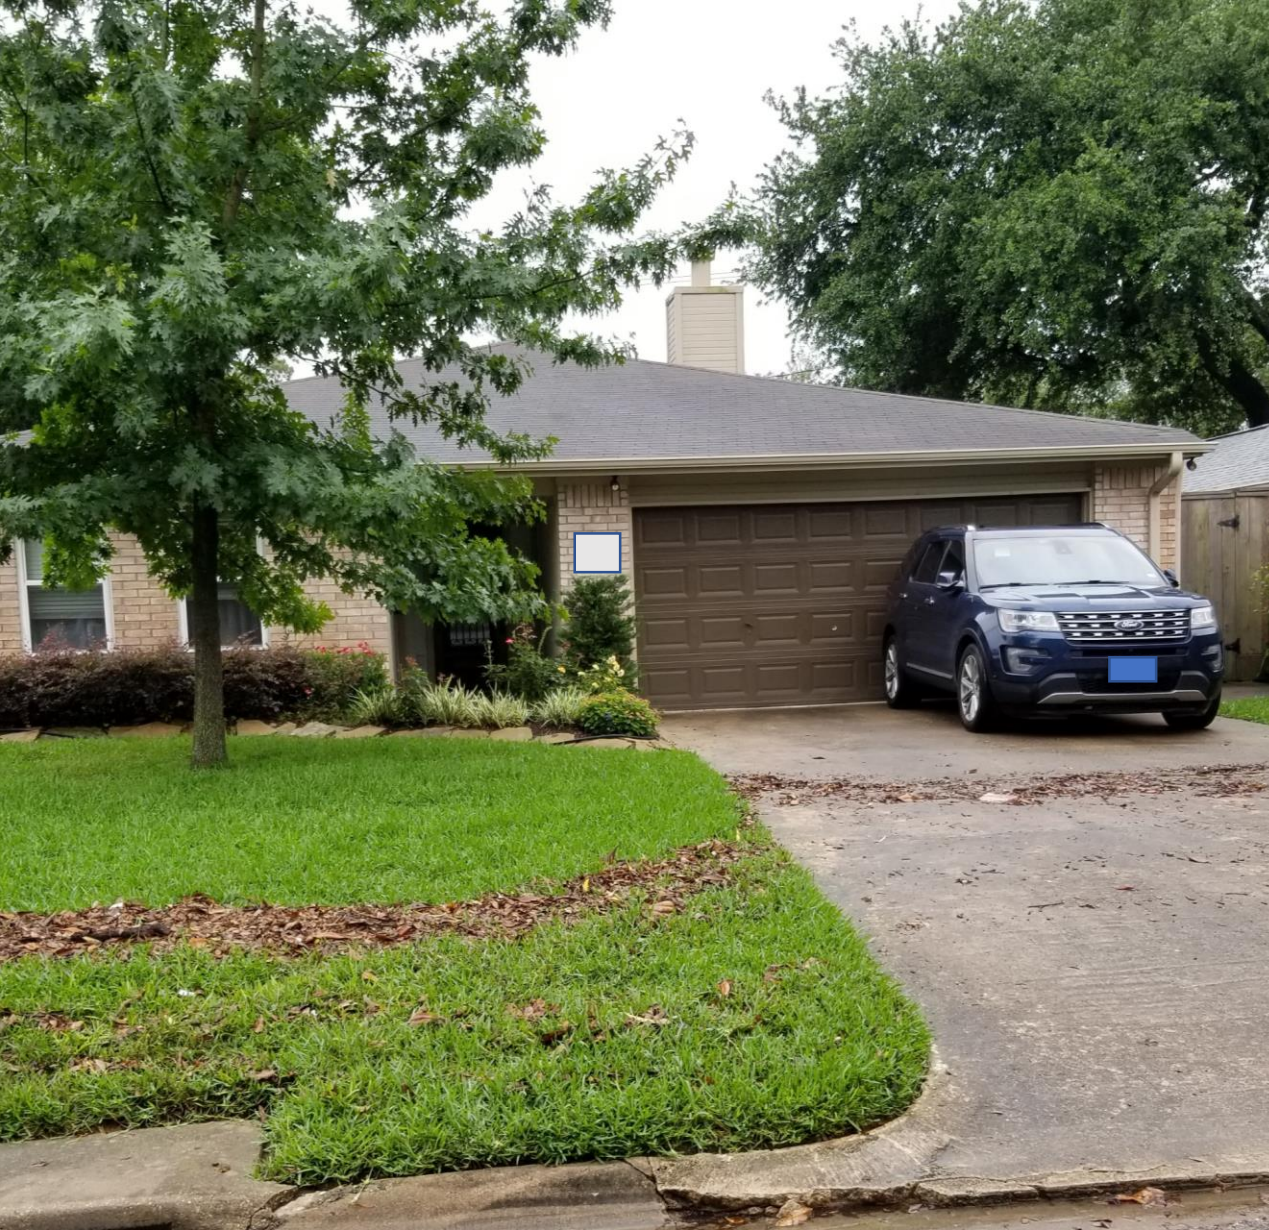
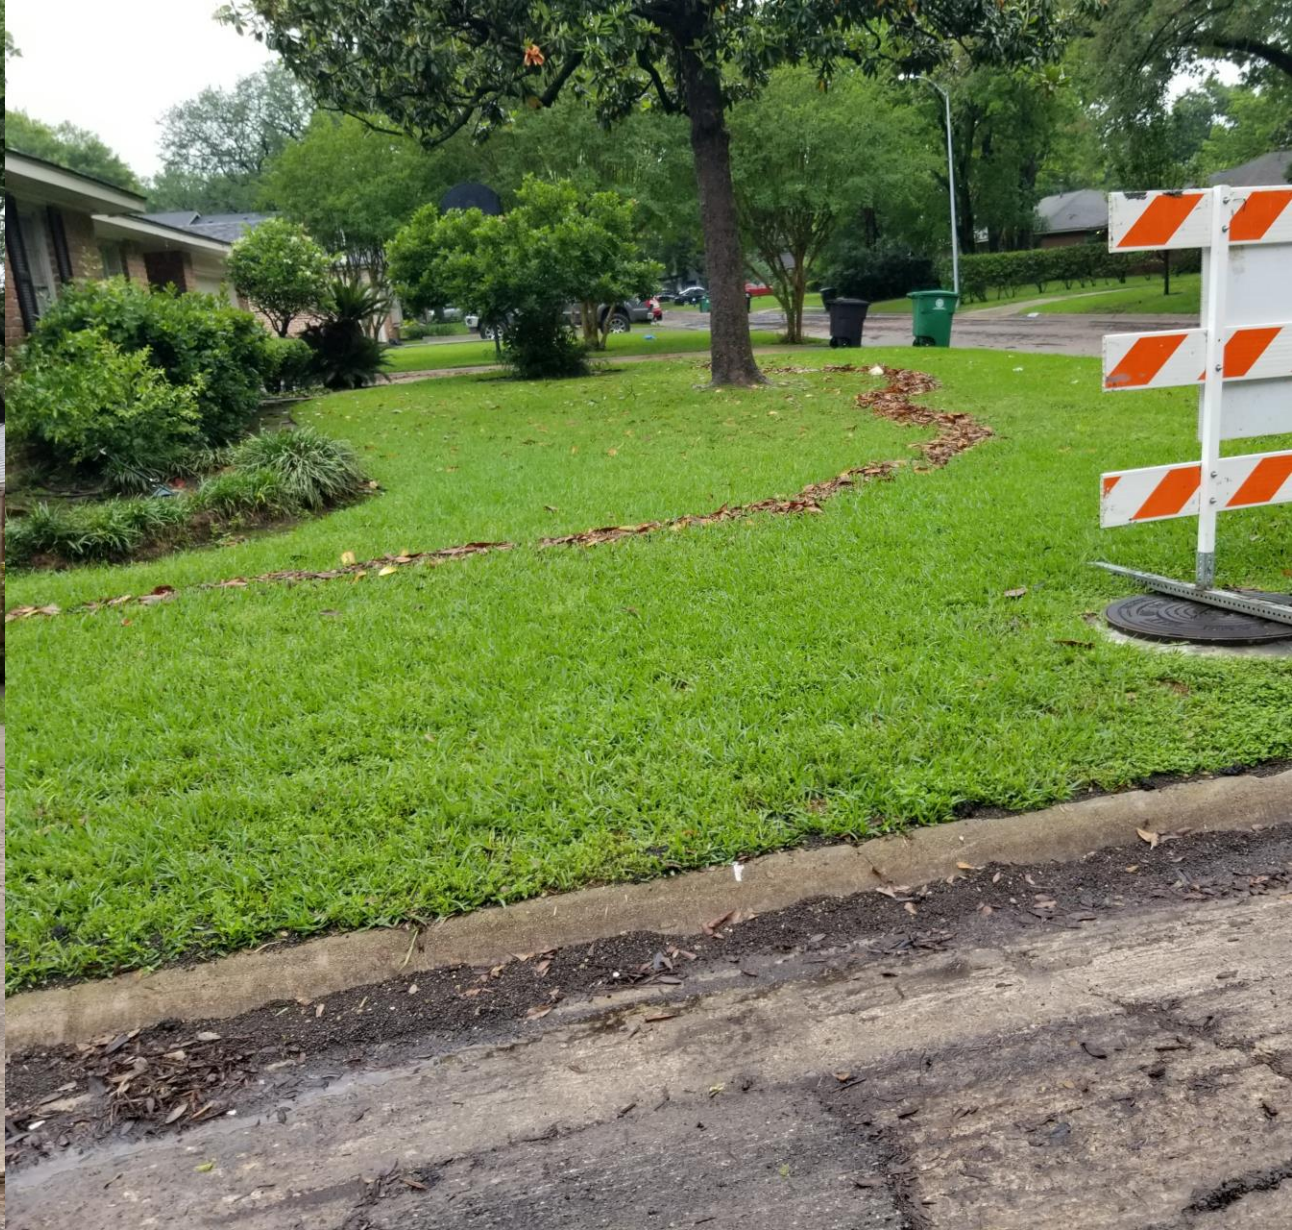
Briar Branch at Bingle

- Short Duration High Intensity Event
